**LABORATORY TEST REPORT**  
**FOR “ROOF CRUSH RESISTANCE” DROP TESTING**

1986 Ford Econoline E150

Test No.  
SAFE001220-01

Prepared by:  
Safety Analysis and Forensic Engineering, LLC  
495 Pine Avenue, Suite A  
Goleta, CA 93117  
Tel: (805) 964-0676  
Fax: (805) 964-7669

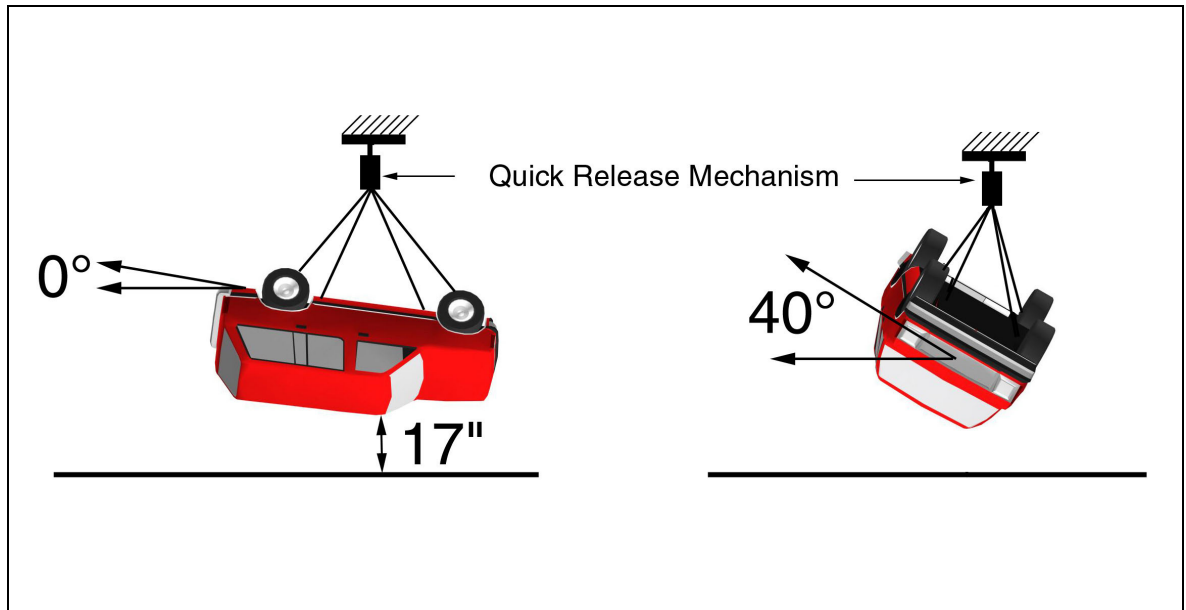
#### Drop Test Configuration Diagram

The test specimen was inspected for defects. The specimen was positioned and secured to the test fixture with a height of the roof at the 'A' pillar positioned 17 inches above the test surface. The pitch angle was zero degrees ( $0^\circ$ ) and the roll angle was forty degrees ( $40^\circ$ ) as shown on figures 5,6, and 7 of Appendix A. In addition, 1265 lbs. of sandbag ballast was placed on the underside of the vehicle.

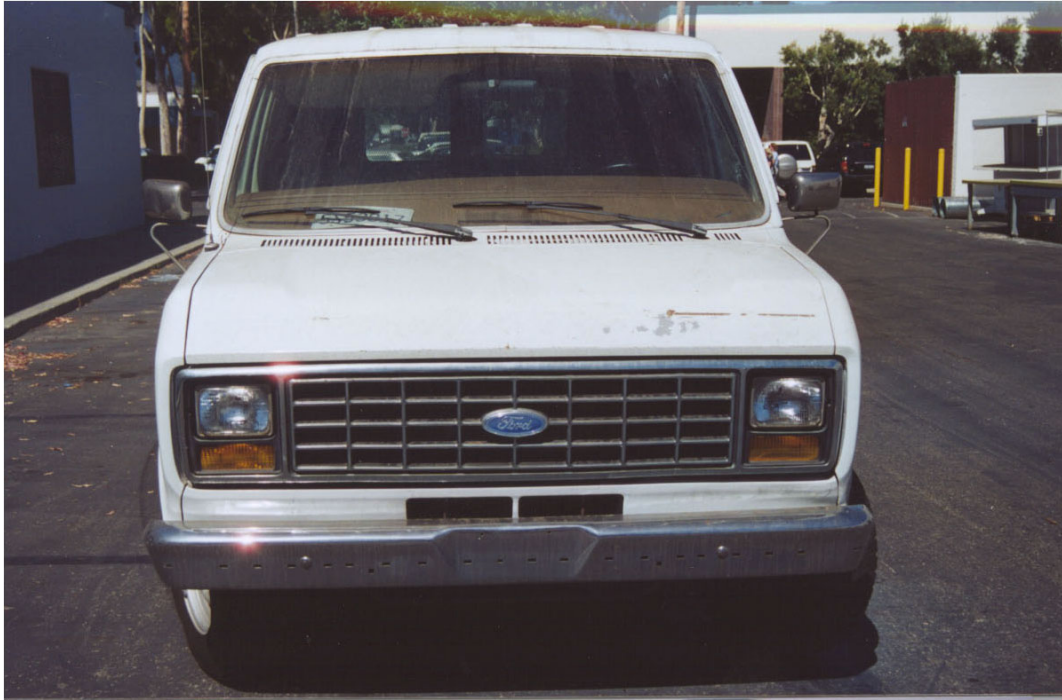
FIGURE 1. PRE-TEST FRONT VIEW

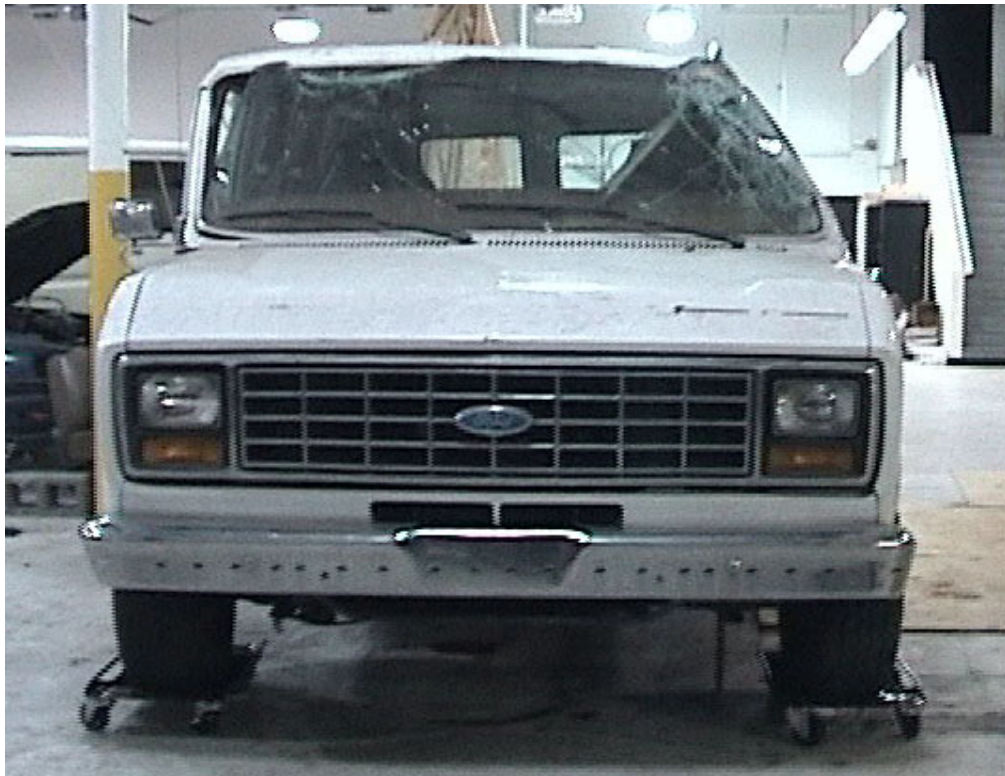
FIGURE 2. POST-TEST FRONT VIEW

The test vehicle was dropped while inverted from 17 inches above the ground with a calculated impact speed of approximately 6.5 mph. The peak resultant acceleration as measured at the vehicle floor between the two front seats was 7.0 g's. The maximum static deformation occurred at the front header measuring 5.8" inward and 0" downward for resultant intrusion of 5.8". Structural failures were observed at the top and bottom of the A-pillars on both sides of the vehicle. Minor parallelogramming occurred along the entire length of the vehicle with driver's side deforming inward and the passenger's side deforming outward.

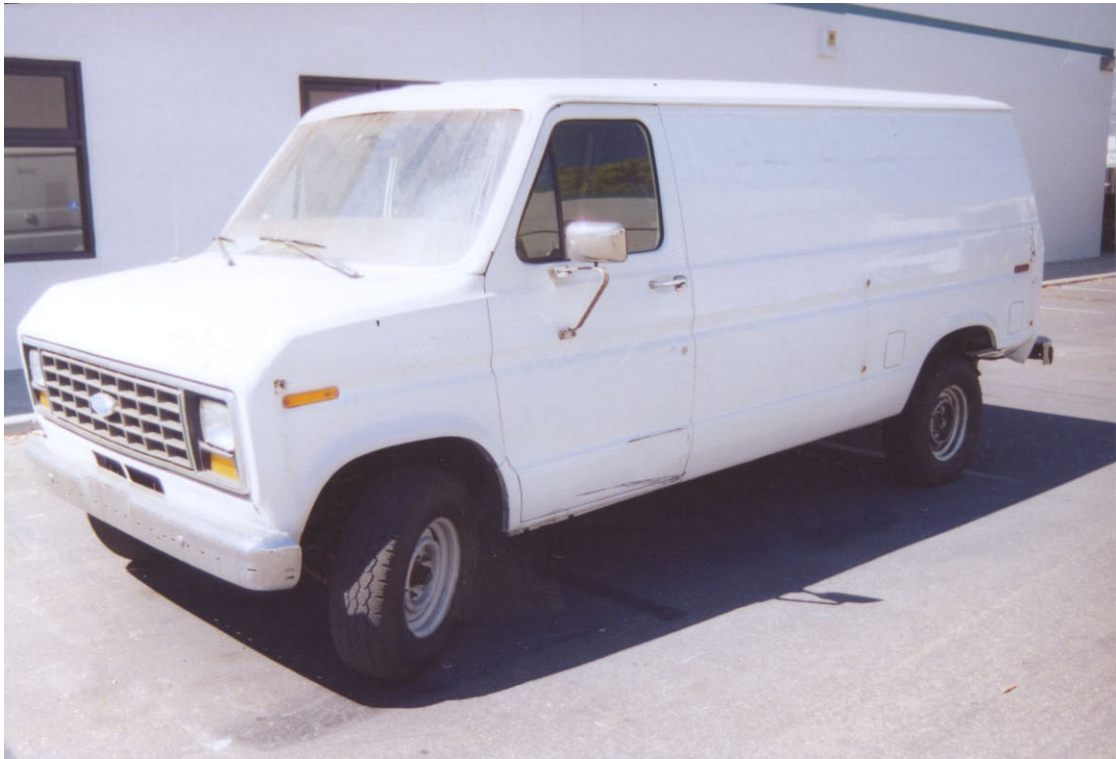
FIGURE 3. PRE-TEST LEFT FRONT  $\frac{3}{4}$  VIEW

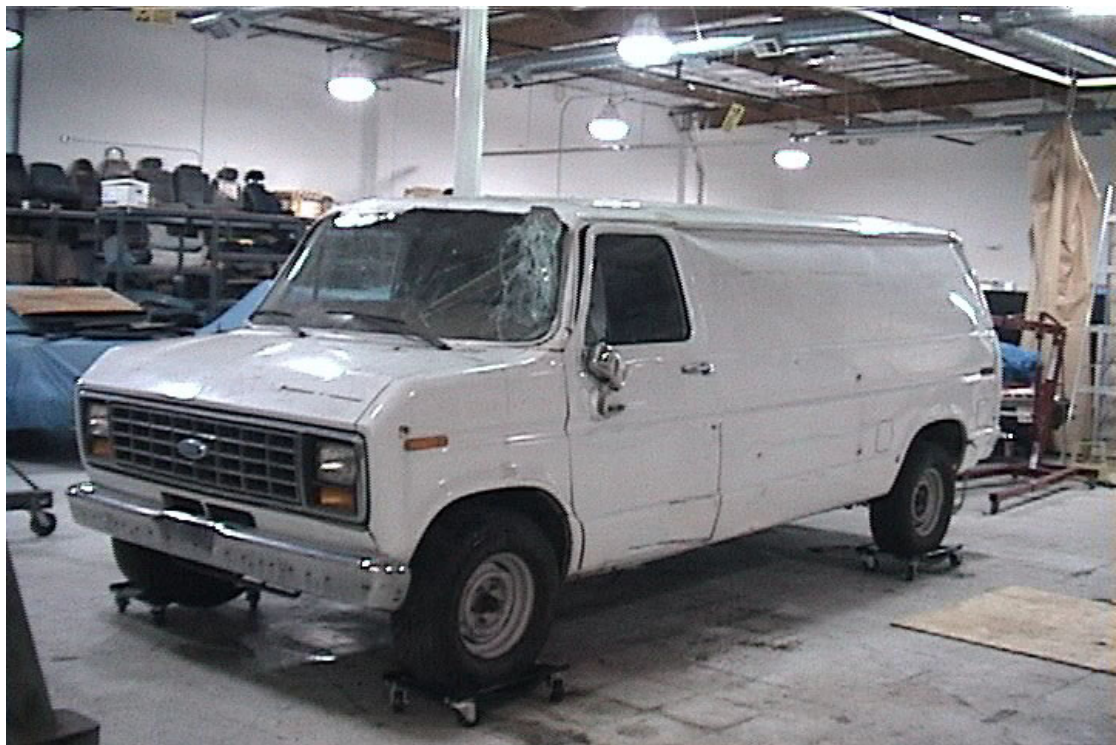
FIGURE 4. POST-TEST LEFT FRONT  $\frac{3}{4}$  VIEW

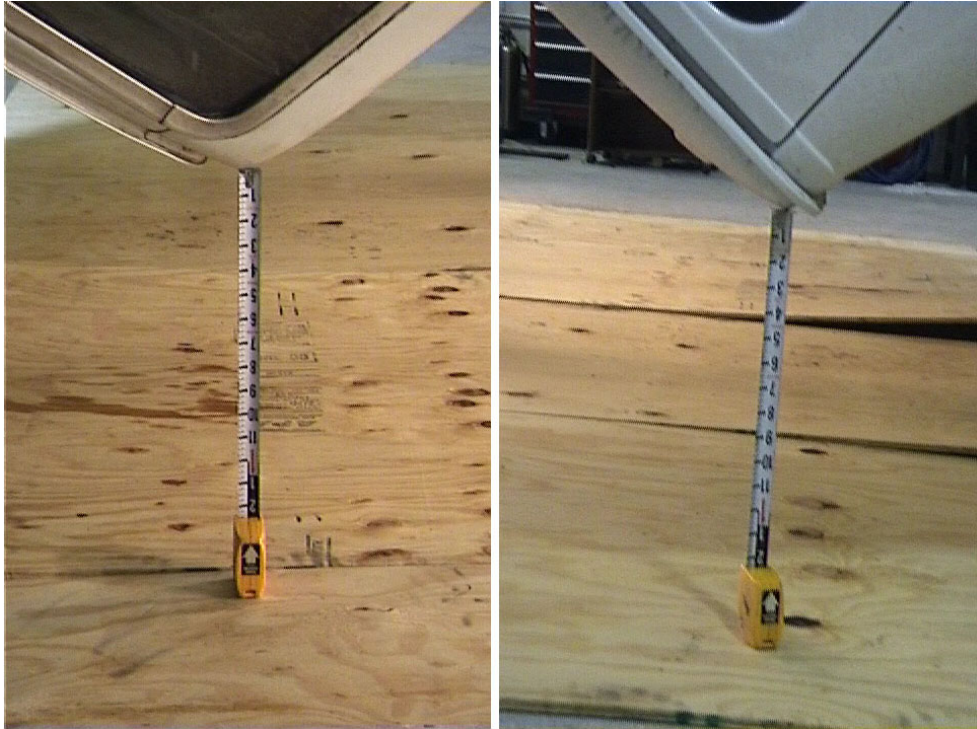
FIGURE 5. PRE-TEST HEIGHT MEASUREMENT (A and F-PILLARS, RESPECTIVELY)

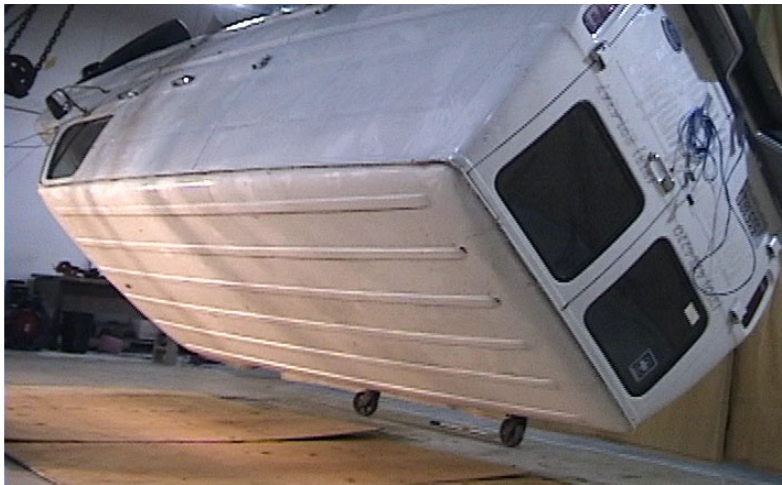
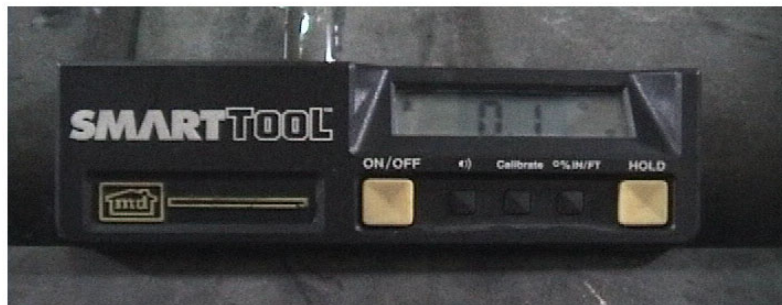
FIGURE 6. PRE-TEST PITCH ANGLE MEASUREMENT

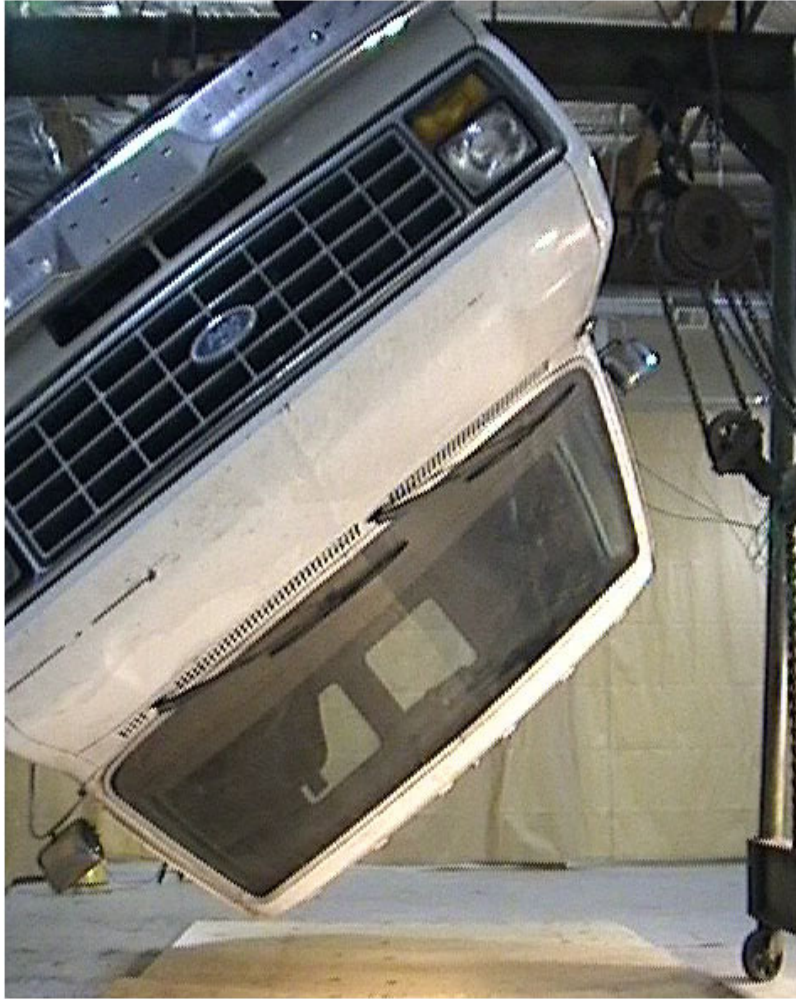
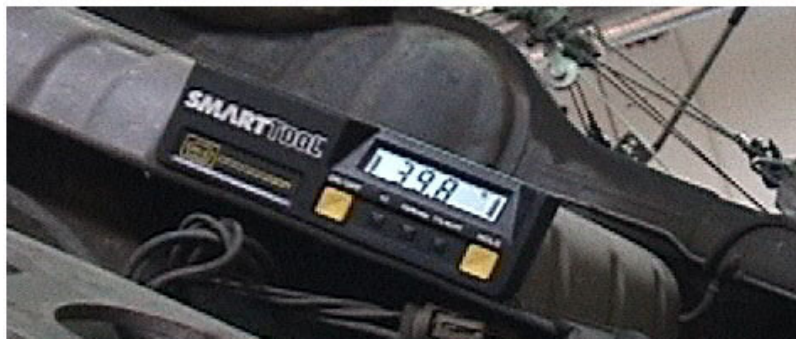
FIGURE 7. PRE-TEST ROLL ANGLE MEASUREMENT

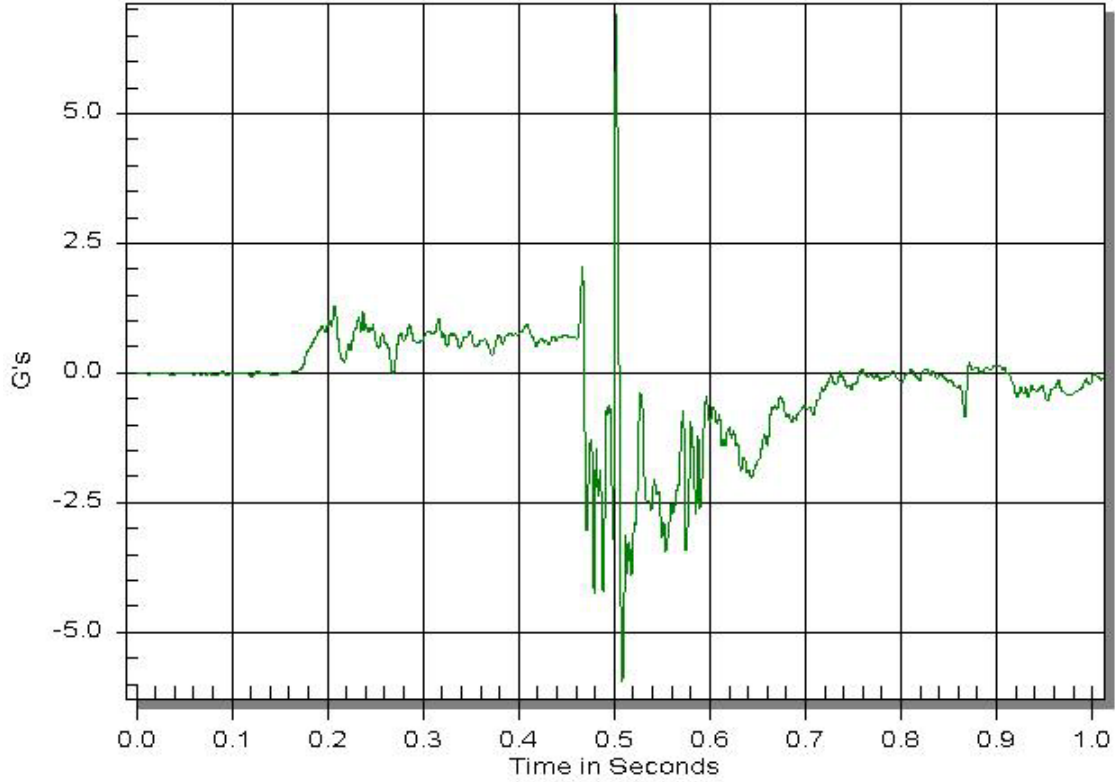
### Acceleration in X-Direction

Ymin -5.968 @ 508.3, Ymax 6.911 @ 501.9

Curve Description:	<b>Accelerometer in X-direction</b>	Test Program:	<b>Modified Drop Test</b>
Maximum Value:	<b>6.911 G's</b> at <b>502 ms</b>	Test Vehicle:	<b>1986 Ford E150</b>
Minimum Value:	<b>-5.968 G's</b> at <b>508 ms</b>	Date of Test:	<b>12/20/00</b>
Filter Class:	<b>60</b>

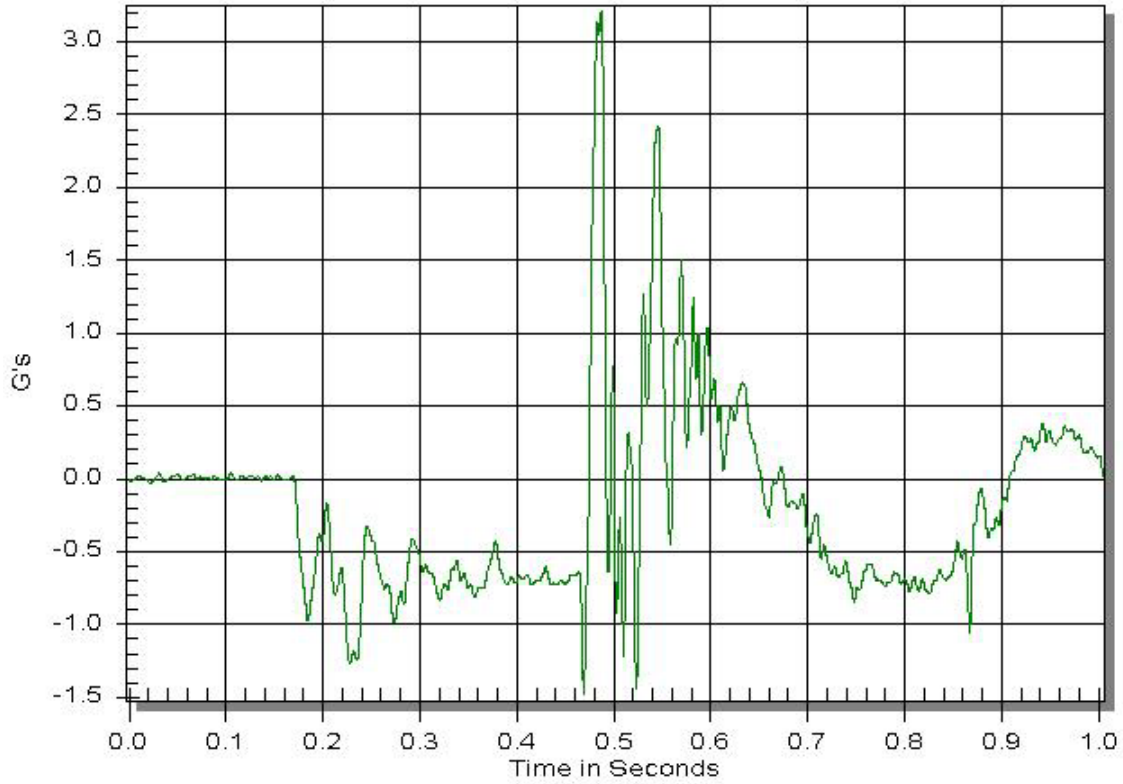
### Acceleration in Y-Direction

Ymin -1.475 @ 468.9, Ymax 3.686 @ 2544.9

Curve Description:	<b>Accelerometer in Y-direction</b>	Test Program:	<b>Modified Drop Test</b>
Maximum Value:	<b>3.686 G's</b> at <b>2545 ms</b>	Test Vehicle:	<b>1986 Ford E150</b>
Minimum Value:	<b>-1.475 G's</b> at <b>469 ms</b>	Date of Test:	<b>12/20/00</b>
Filter Class:	<b>60</b>

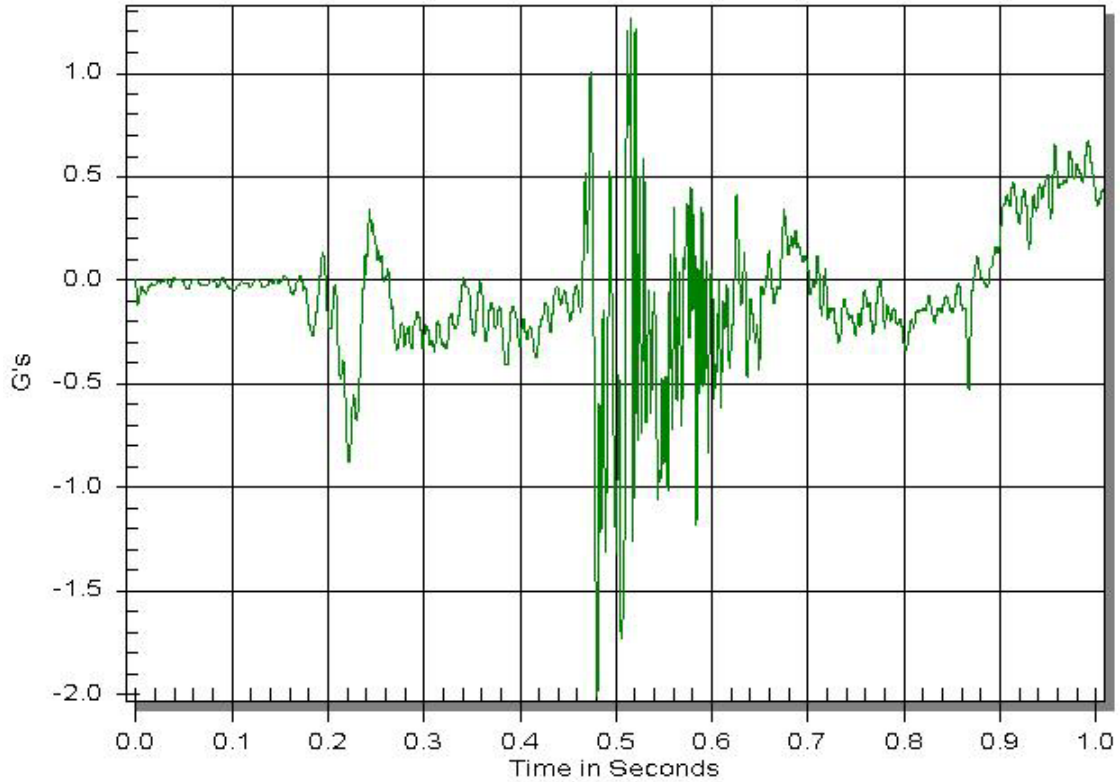
### Acceleration in Z-Direction

Ymin -2.003 @ 480.4, Ymax 1.270 @ 515.3

Curve Description:	<b>Accelerometer in Z-direction</b>	Test Program:	<b>Modified Drop Test</b>
Maximum Value:	<b>1.270G's</b> at <b>515 ms</b>	Test Vehicle:	<b>1986 Ford E150</b>
Minimum Value:	<b>-2.003 G's</b> at <b>480 ms</b>	Date of Test:	<b>12/20/00</b>
Filter Class:	<b>60</b>

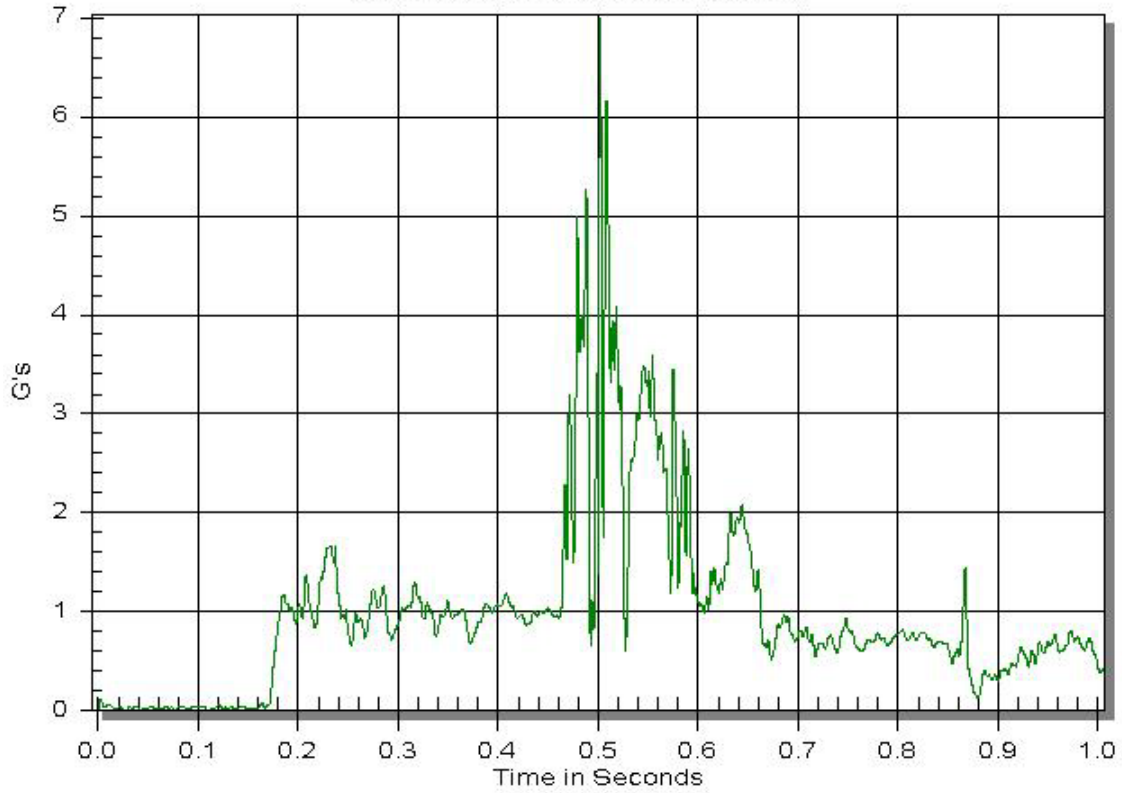
### Resultant Acceleration

Ymin 0.000 @ 0.0, Ymax 6.993 @ 501.9

Curve Description:	<b>Resultant Acceleration</b>	Test Program:	<b>Modified Drop Test</b>
Maximum Value:	<b>6.993G's</b> at <b>502 ms</b>	Test Vehicle:	<b>1986 Ford E150</b>
Minimum Value:	<b>0.000 G's</b> at <b>0 ms</b>	Date of Test:	<b>12/20/00</b>
Filter Class:	<b>60</b>

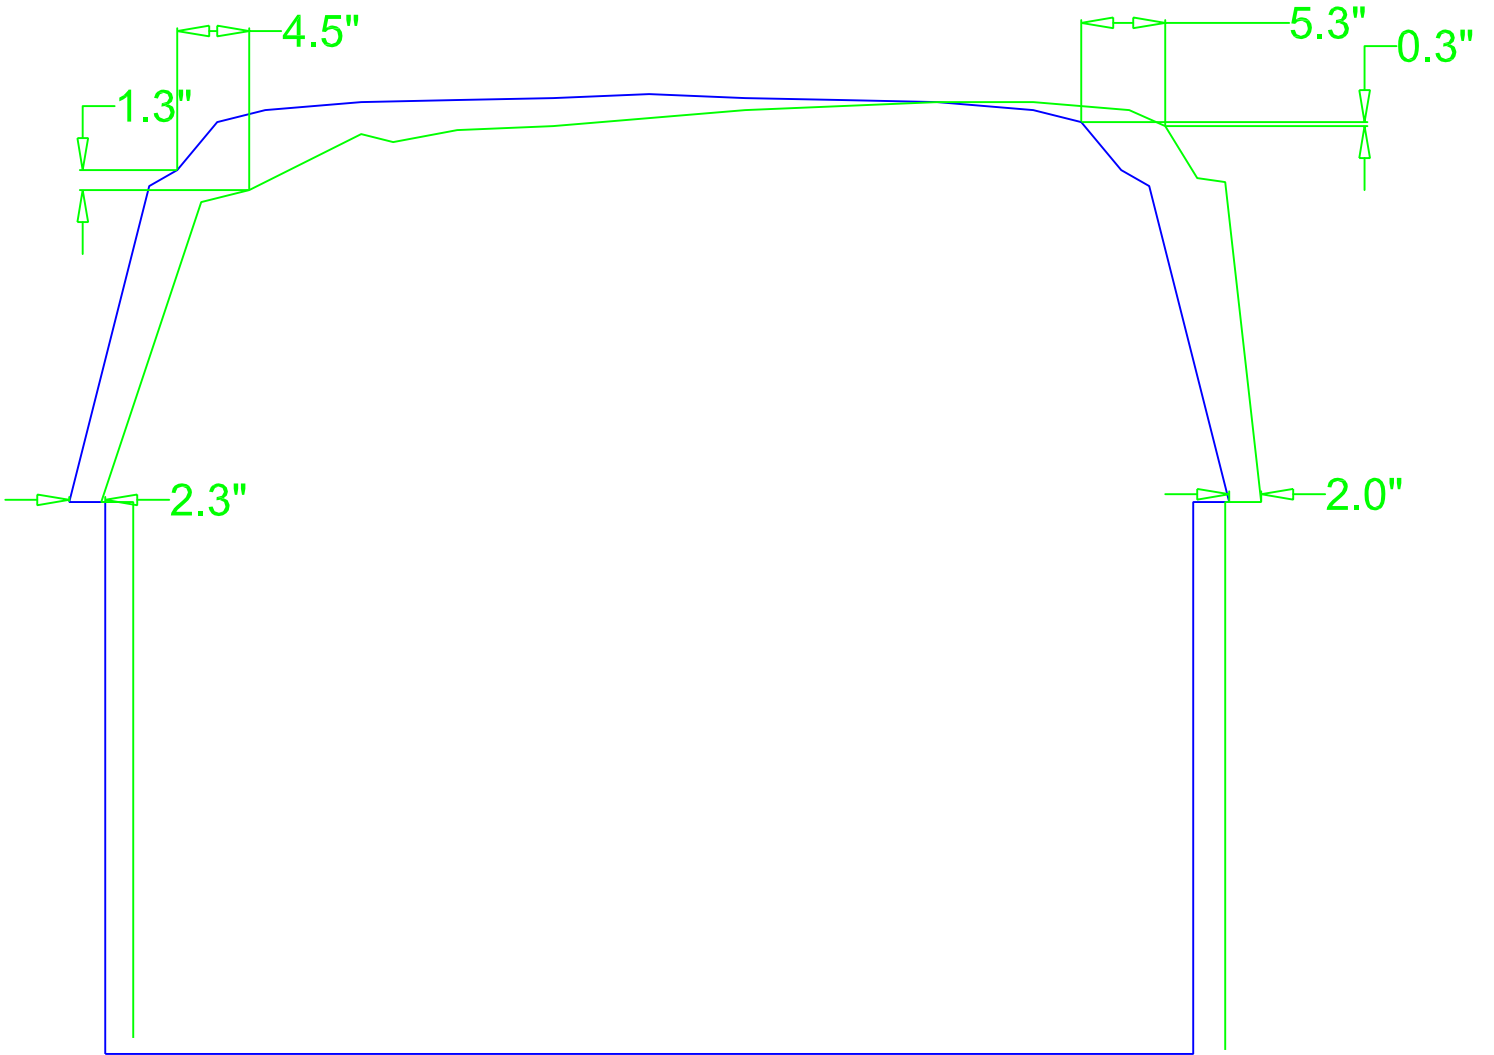
RESULTANT ROOF CRUSH AT LEADING EDGE OF B-PILLAR

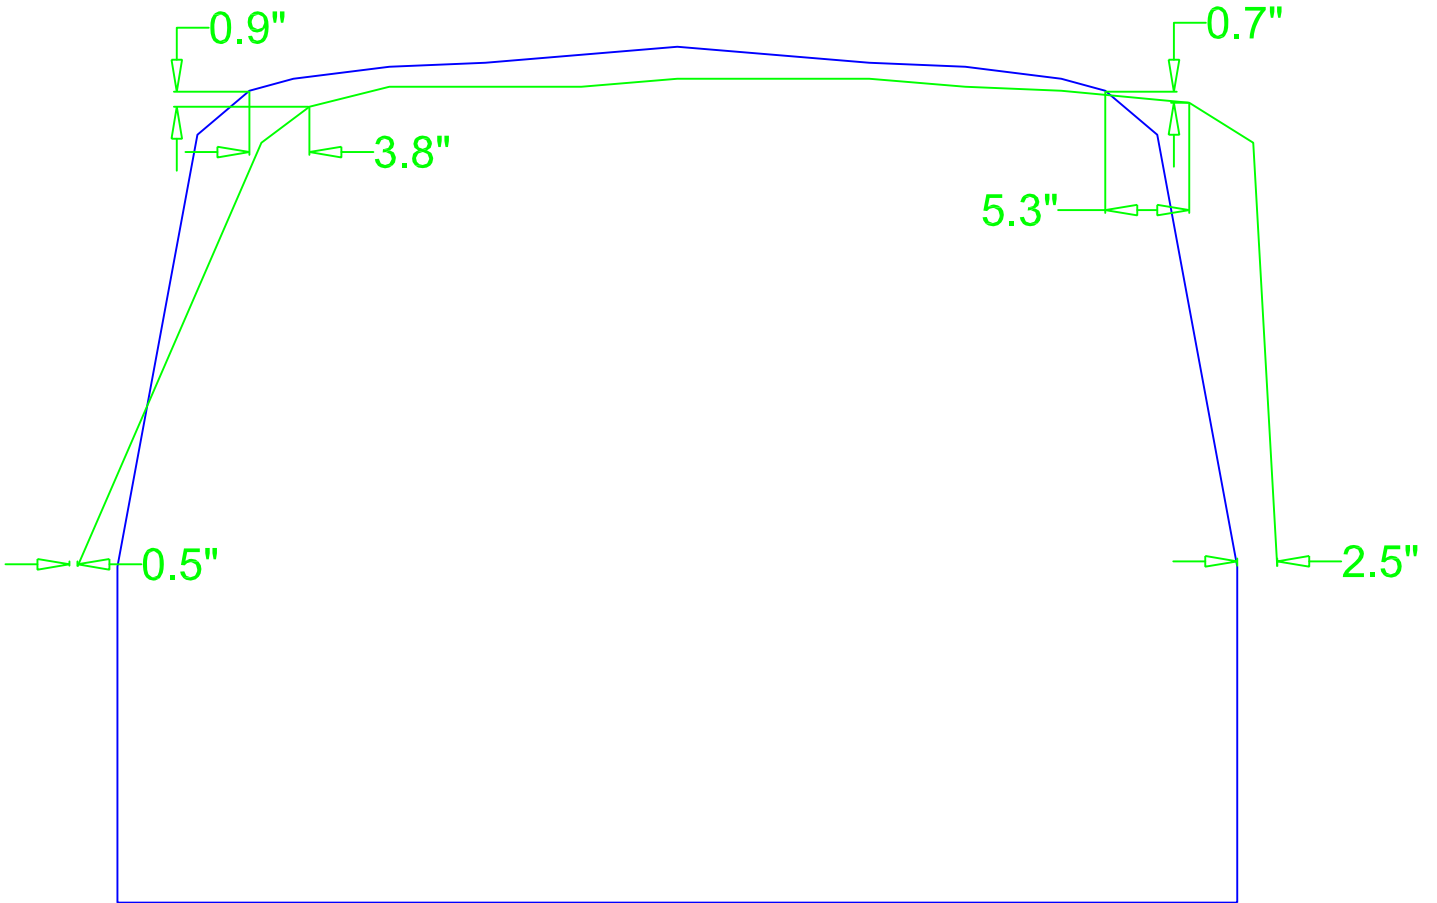
**RESULTANT ROOF CRUSH 20"  
REARWARD OF LEADING EDGE OF B-PILLAR**

NOTE: Modified roof profile is 1/2" lower due to roll bar under headliner

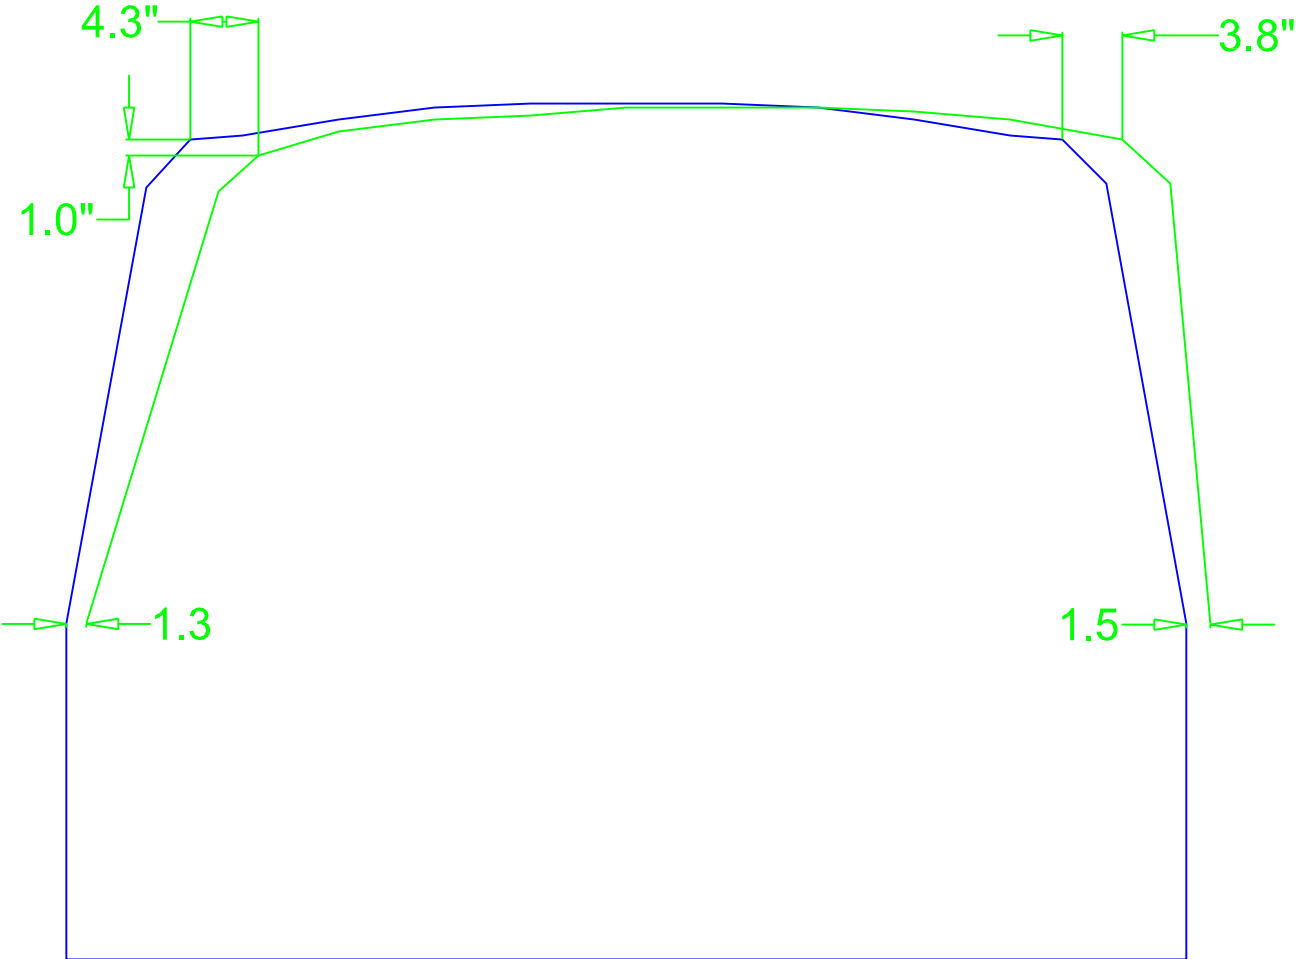
RESULTANT ROOF CRUSH 59.5"  
REARWARD OF LEADING EDGE OF B-PILLAR

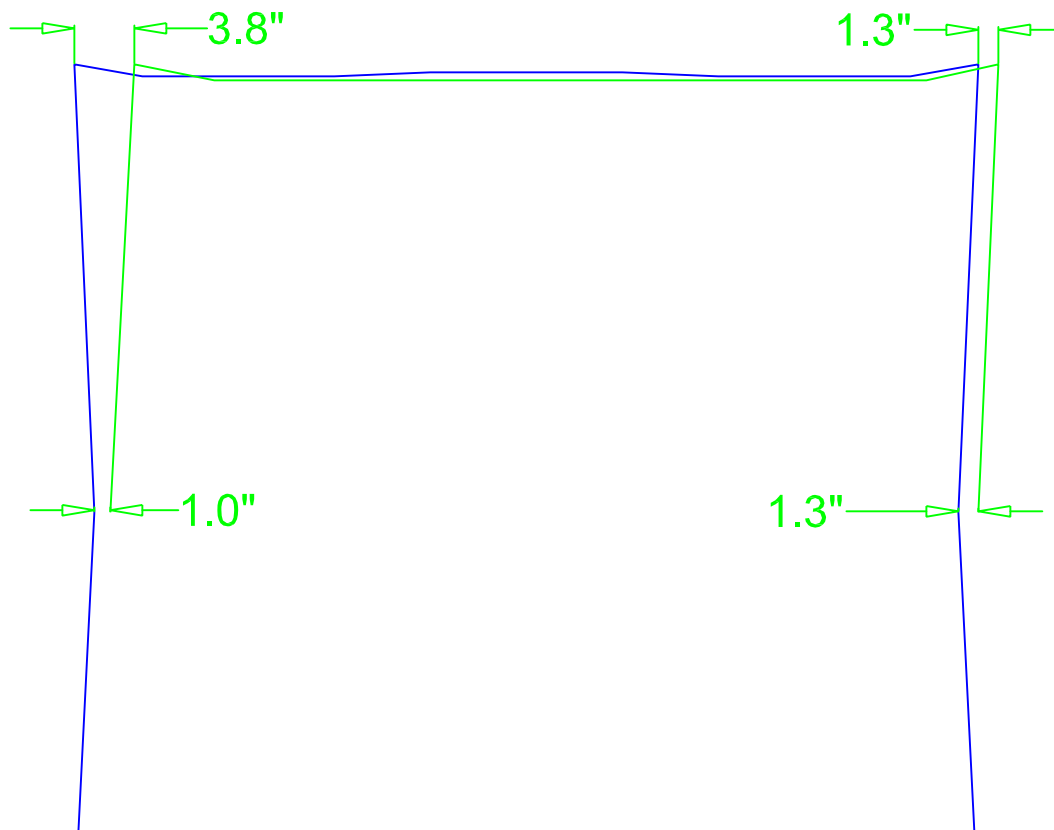
RESULTANT CRUSH AT REAR DOOR OPENING  
(130" REARWARD OF LEADING EDGE OF B-PILLAR)
