Stock 1997 Ford Explorer

Pole Test

SAFE050603

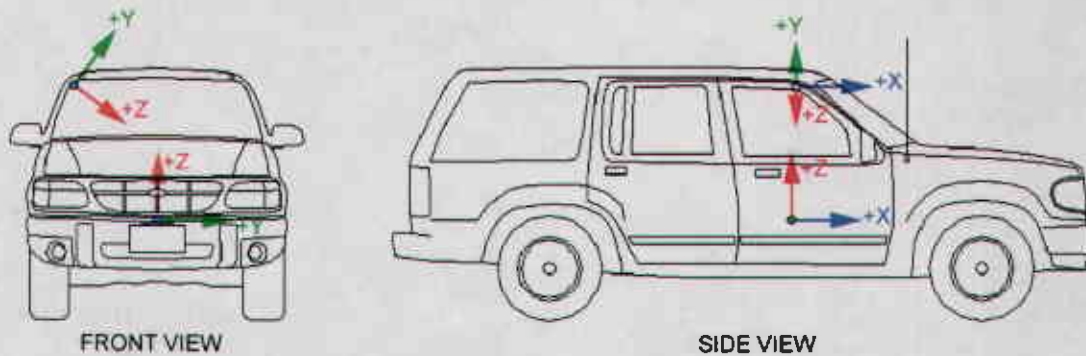
FIGURE 1: ACCELEROMETER DIAGRAM

The 1997 Ford Explorer (see Appendix A for test vehicle identification data) was subjected to a roof-to-pole impact on May 6, 2003. The test vehicle was inspected for defects. The doors were closed and the power front seats were placed in their the mid-point longitudinally and the lowest vertical settings. The test vehicle was equipped with a Psi-tronix DVT-50A displacement transducer mounted to the top of the driver's side A-pillar. A tri-axial array of Endevco 7231c-750TS accelerometers were mounted on the center tunnel at the vehicle's approximate center of gravity. (Figure 1) A tri-axial array of Endevco 7264B-2000T accelerometers were mounted the vehicle's side header adjacent to the intended point of first contact.(Figure 1)

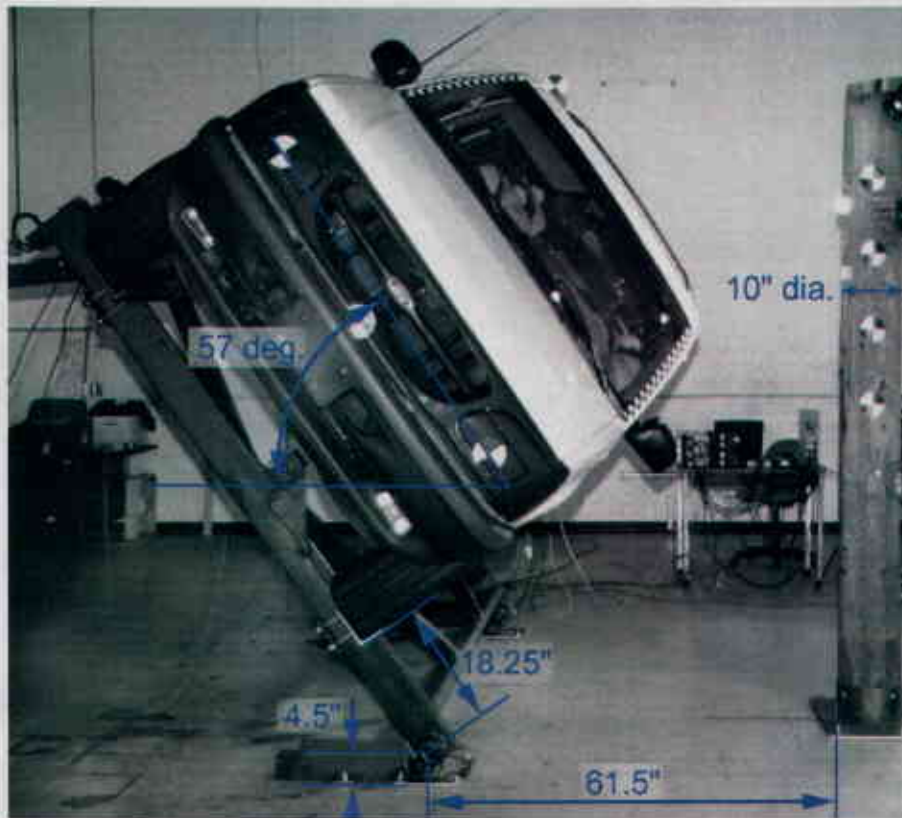
FIGURE 2: POLE TEST CONFIGURATION DIAGRAM

Four real-time and two high-speed cameras were used to document the test from multiple angles. Four water dummies were belted into the occupant compartment with the production 3-point restraints. Ballast was placed in the front foot wells and the rear cargo area. The total test weight of the vehicle was 5118 lb.(See Appendix A for vehicle specifications) The vehicle was placed on a tilt table, adjacent to a wooden utility pole, and rotated up to 57 degrees from horizontal. The vehicle was chained to the tilt table at the passenger frame rail and a 6" lip next to the driver's side tires maintained the orientation of the test vehicle. When an inline release mechanism was disengaged at the chain and frame connection, the vehicle was free to rotate under its own weight into the wooden pole (see Figure 2 for test setup). The vehicle rotated such that the driver side roof rail just cleared the pole and the primary impact was at the passenger side roof rail between the A- and B-pillars. This impact occurred at approximately 9 mph (at the roof rail). Additional photographs of the vehicle and test setup are shown in Appendix C.

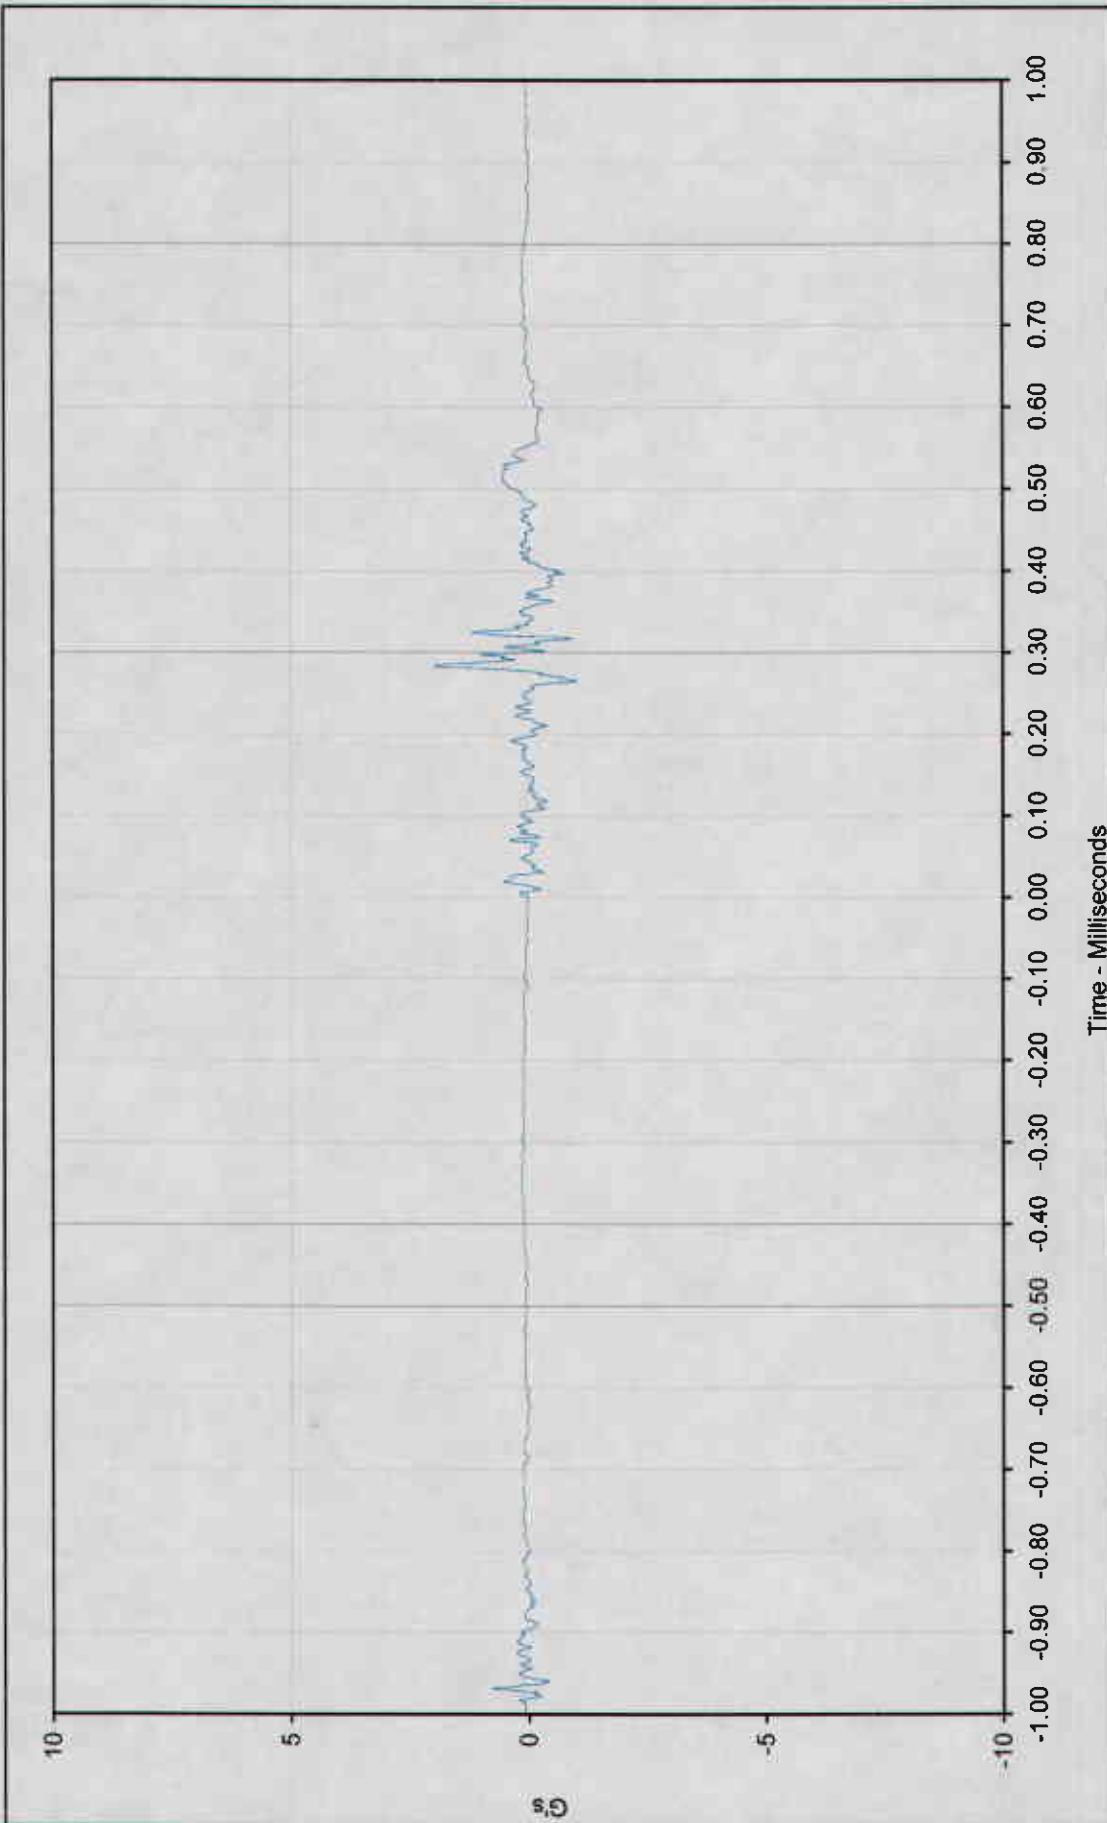
Curve Description	CURNO	Units	Max	Time	Min	Time	SAE Class
CG acceleration x	001	G's	2.0	0.284	-1.0	0.266	60

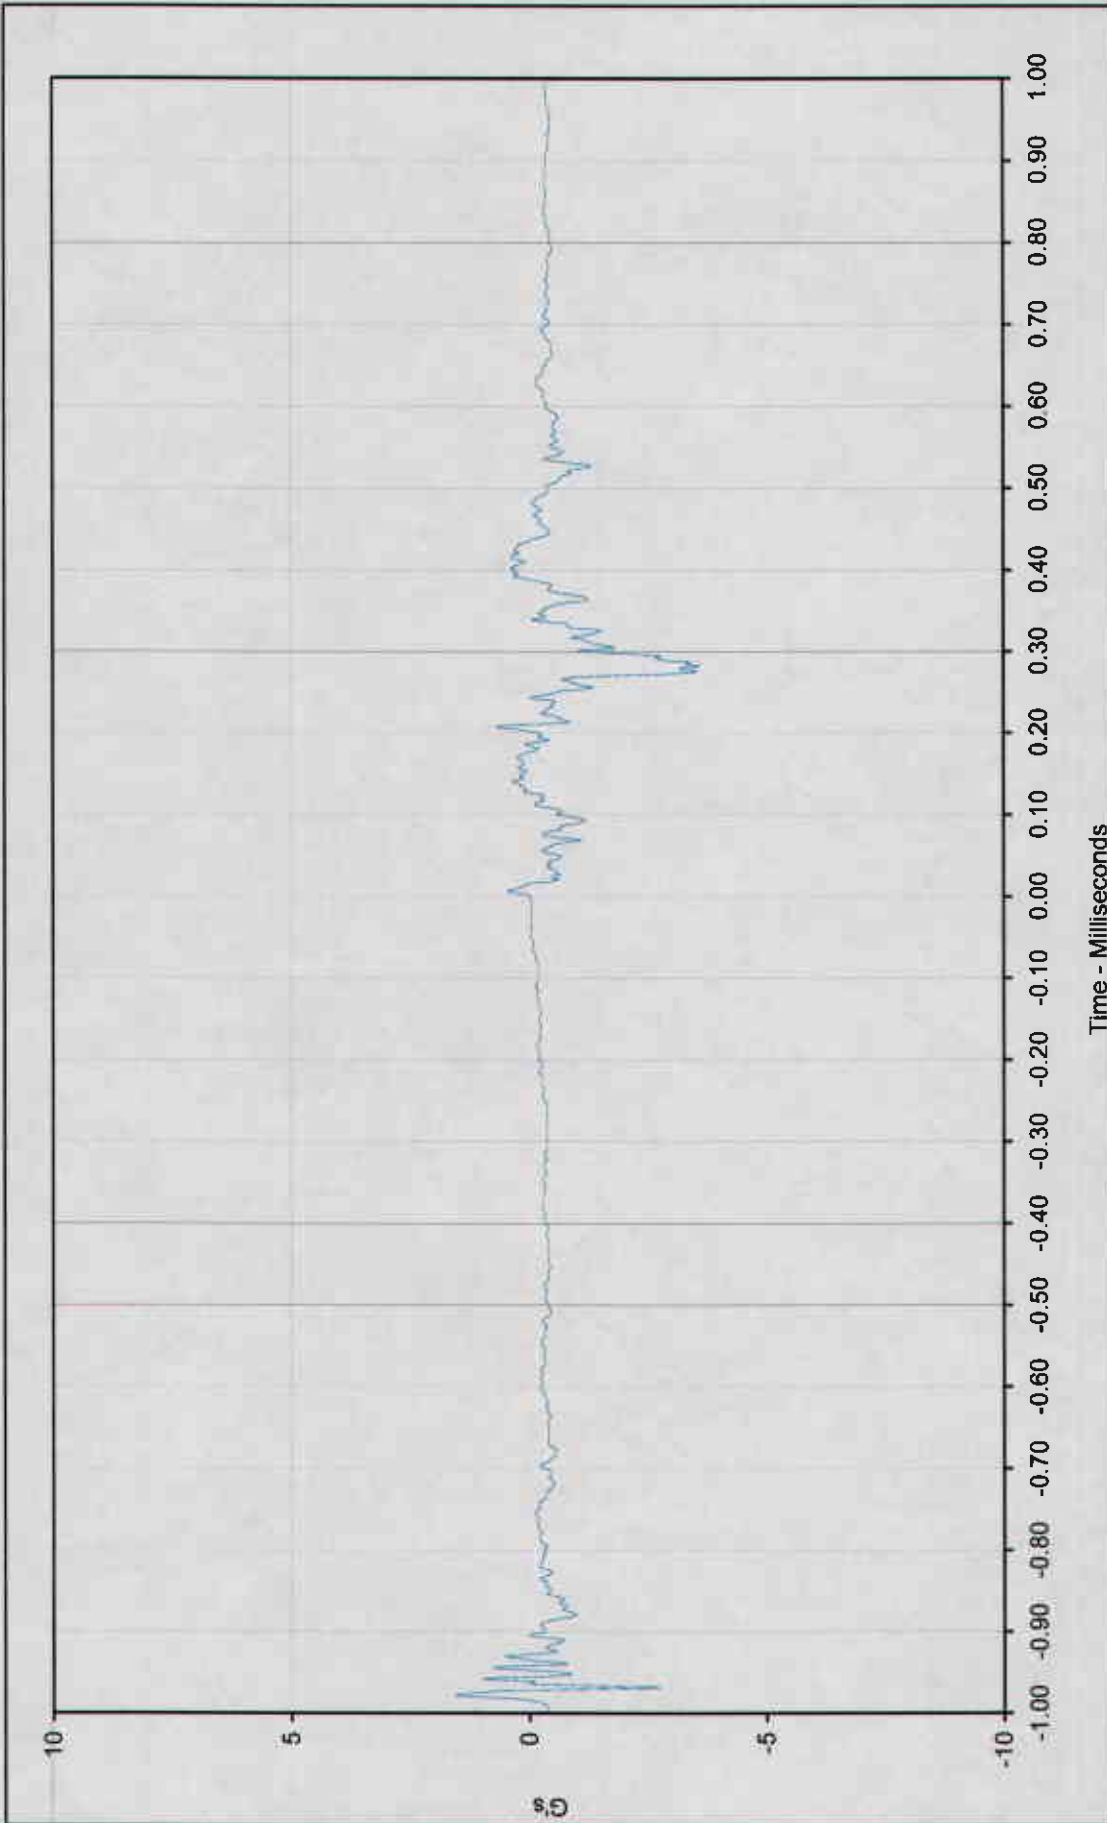
Curve Description	CURNO	Units	Max	Time	Min	Time	SAE Class
CG acceleration y	002	G's	1.6	-0.977	-3.6	0.283	60

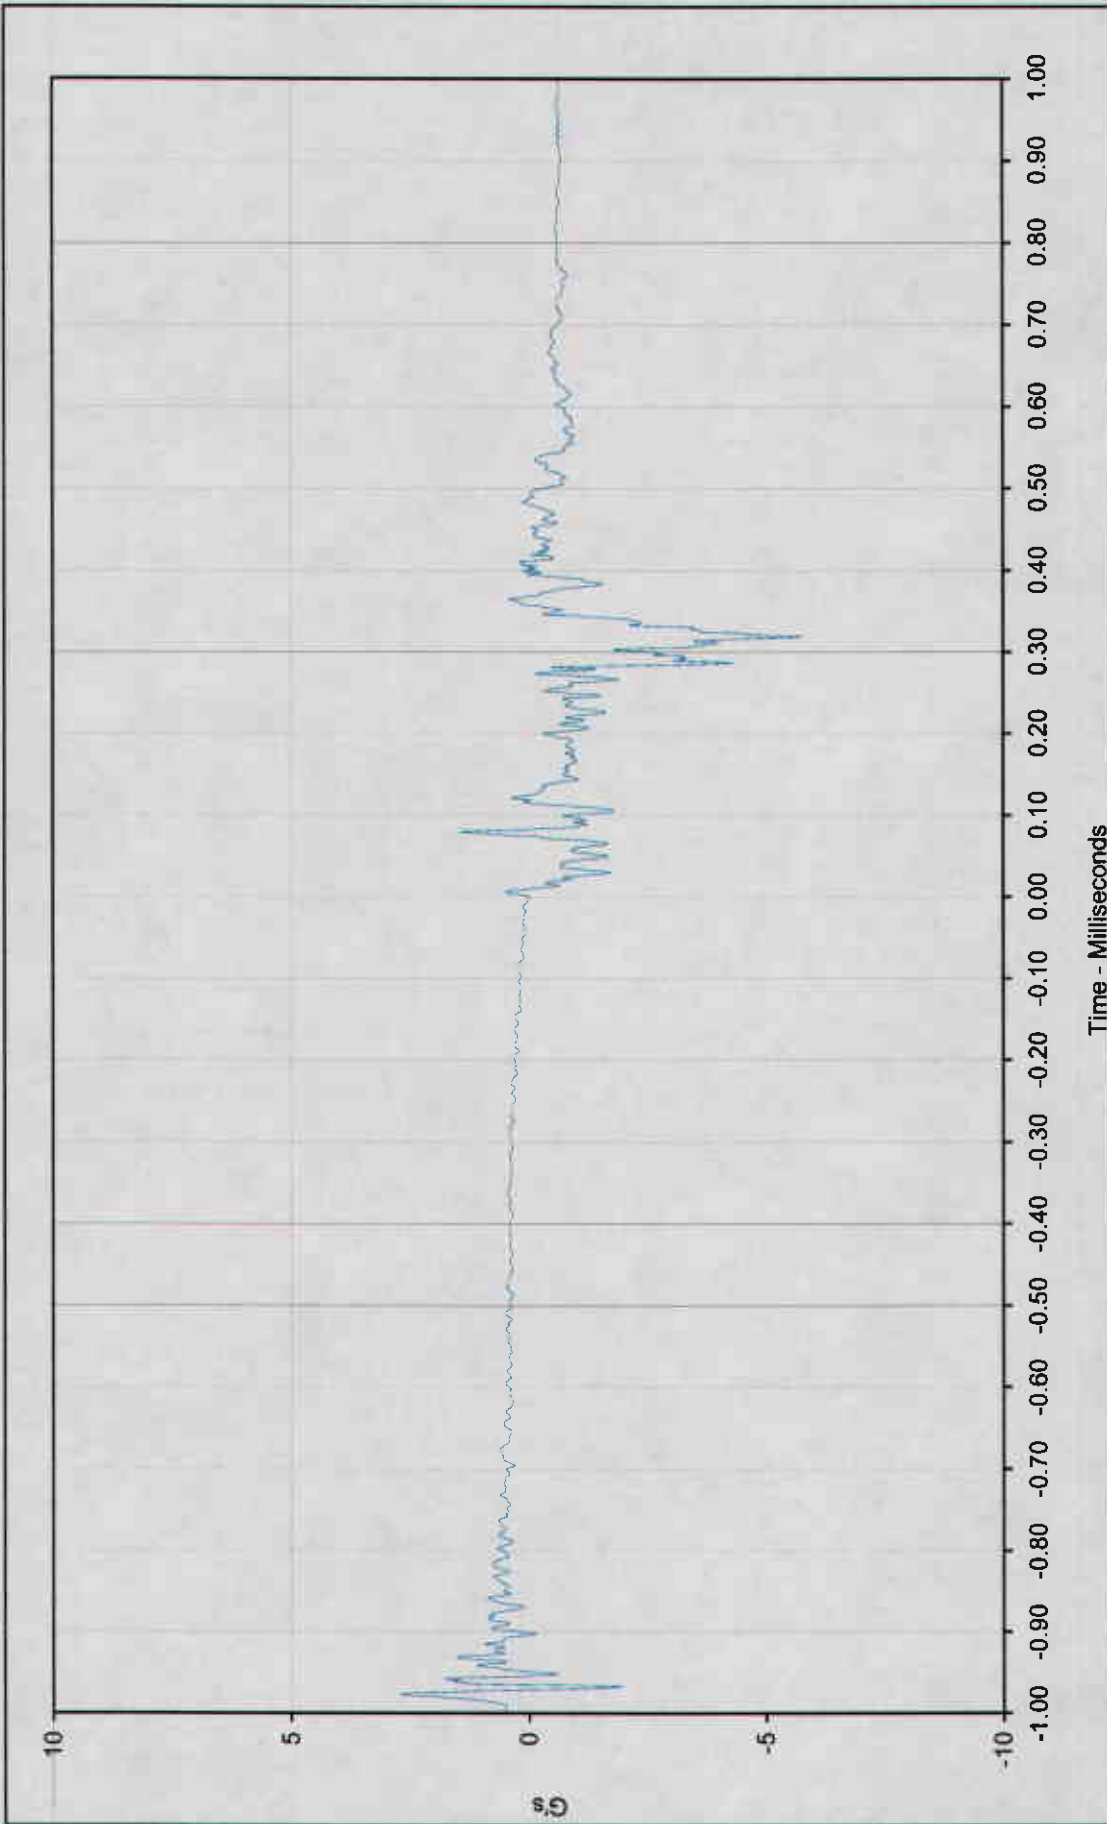
Curve Description	CURNO	Units	Max	Time	Min	Time	SAE Class
CG Acceleration z	003	G's	2.7	-0.976	-5.7	0.319	60

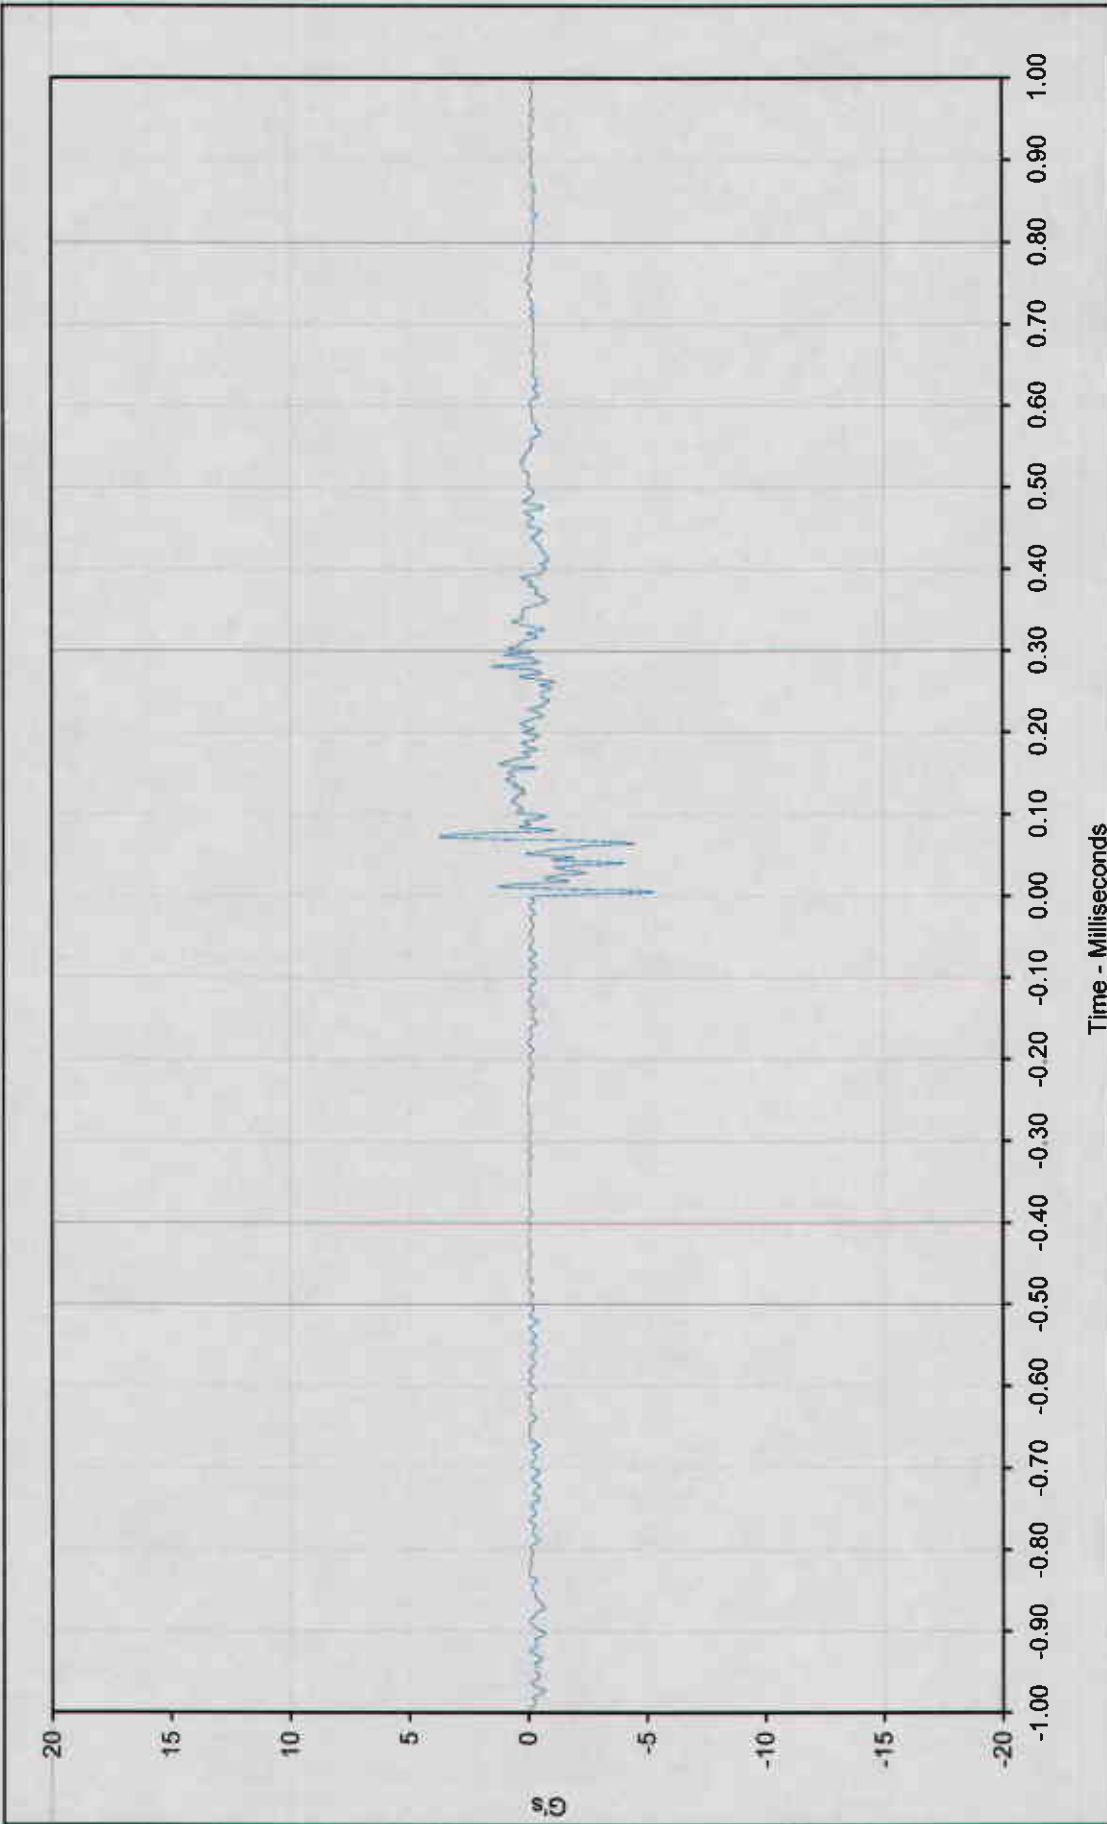
Curve Description	CURNO	Units	Max	Time	Min	Time	SAE Class
Roof Rail Acceleration x	004	G's	3.7	0.073	-5.3	0.005	60

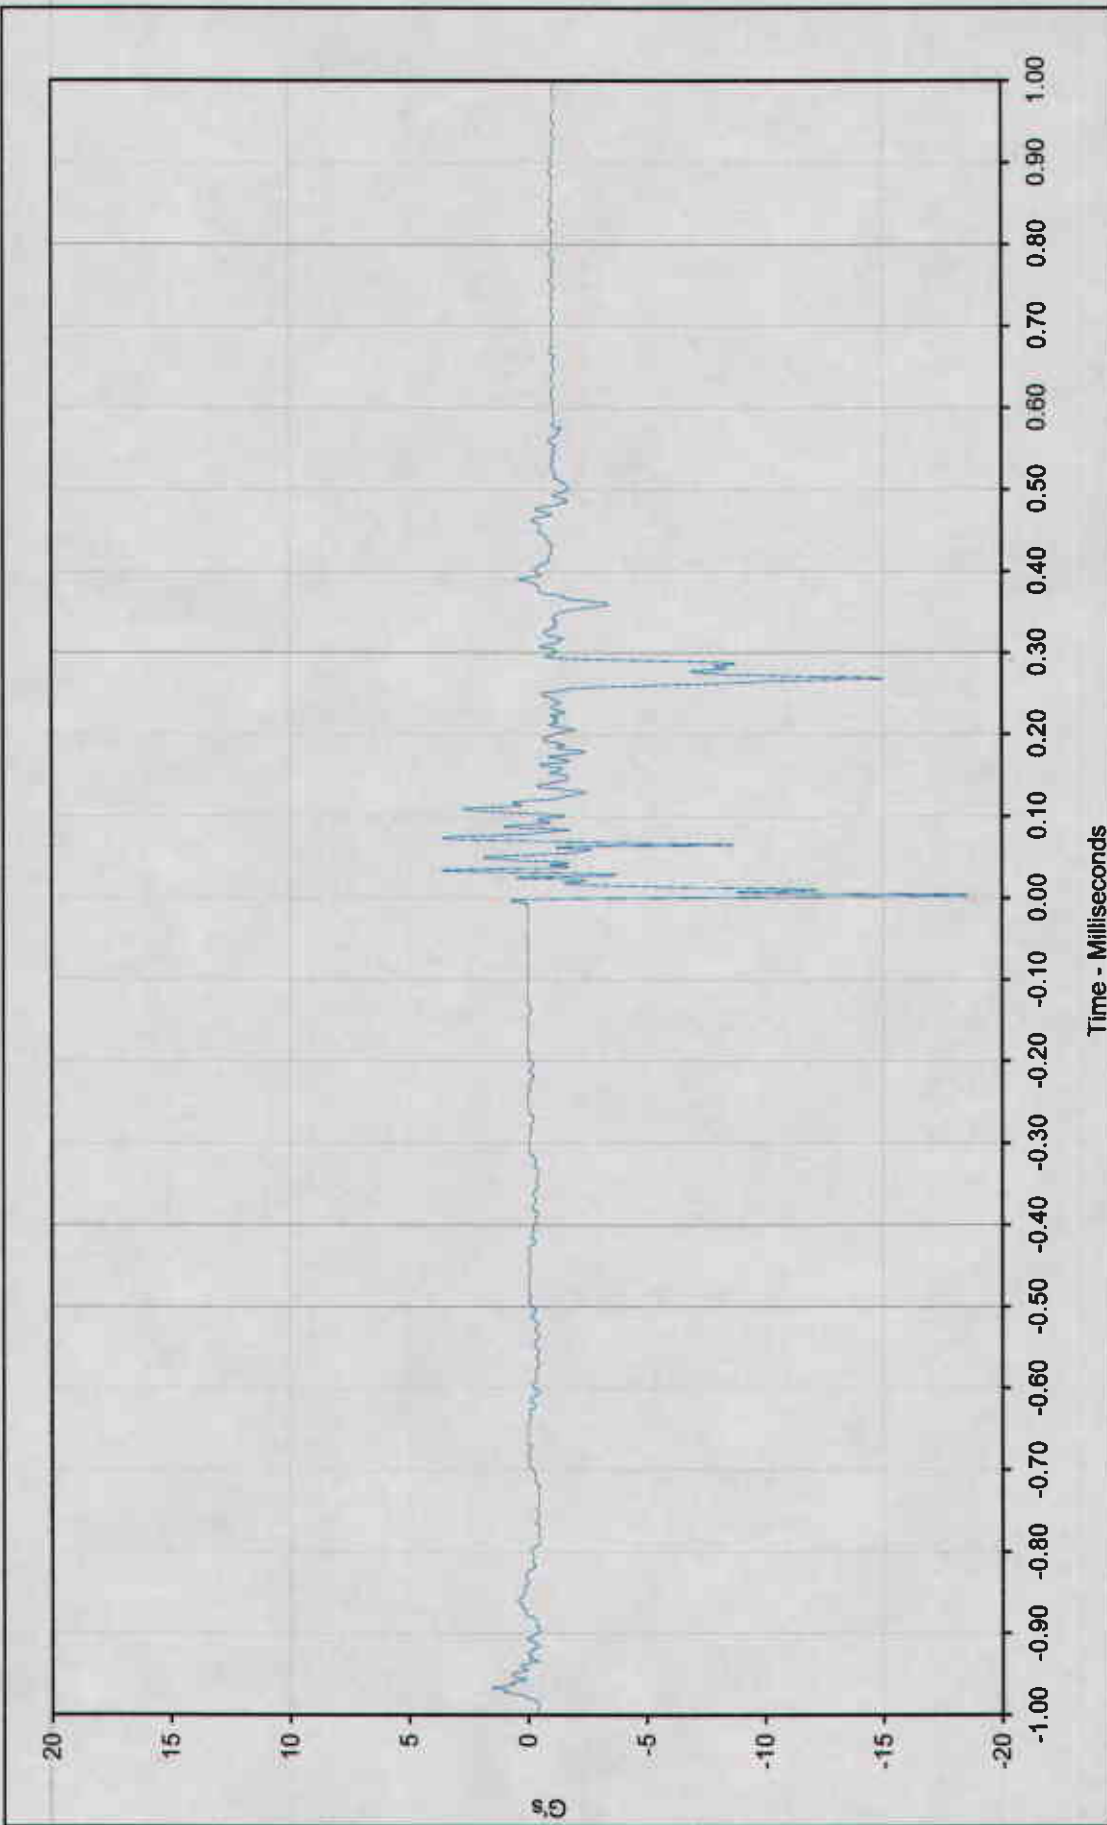
Curve Description	CURNO	Units	Max	Time	Min	Time	SAE Class
Roof Rail Acceleration y	005	G's	3.6	0.033	-18.6	0.003	60

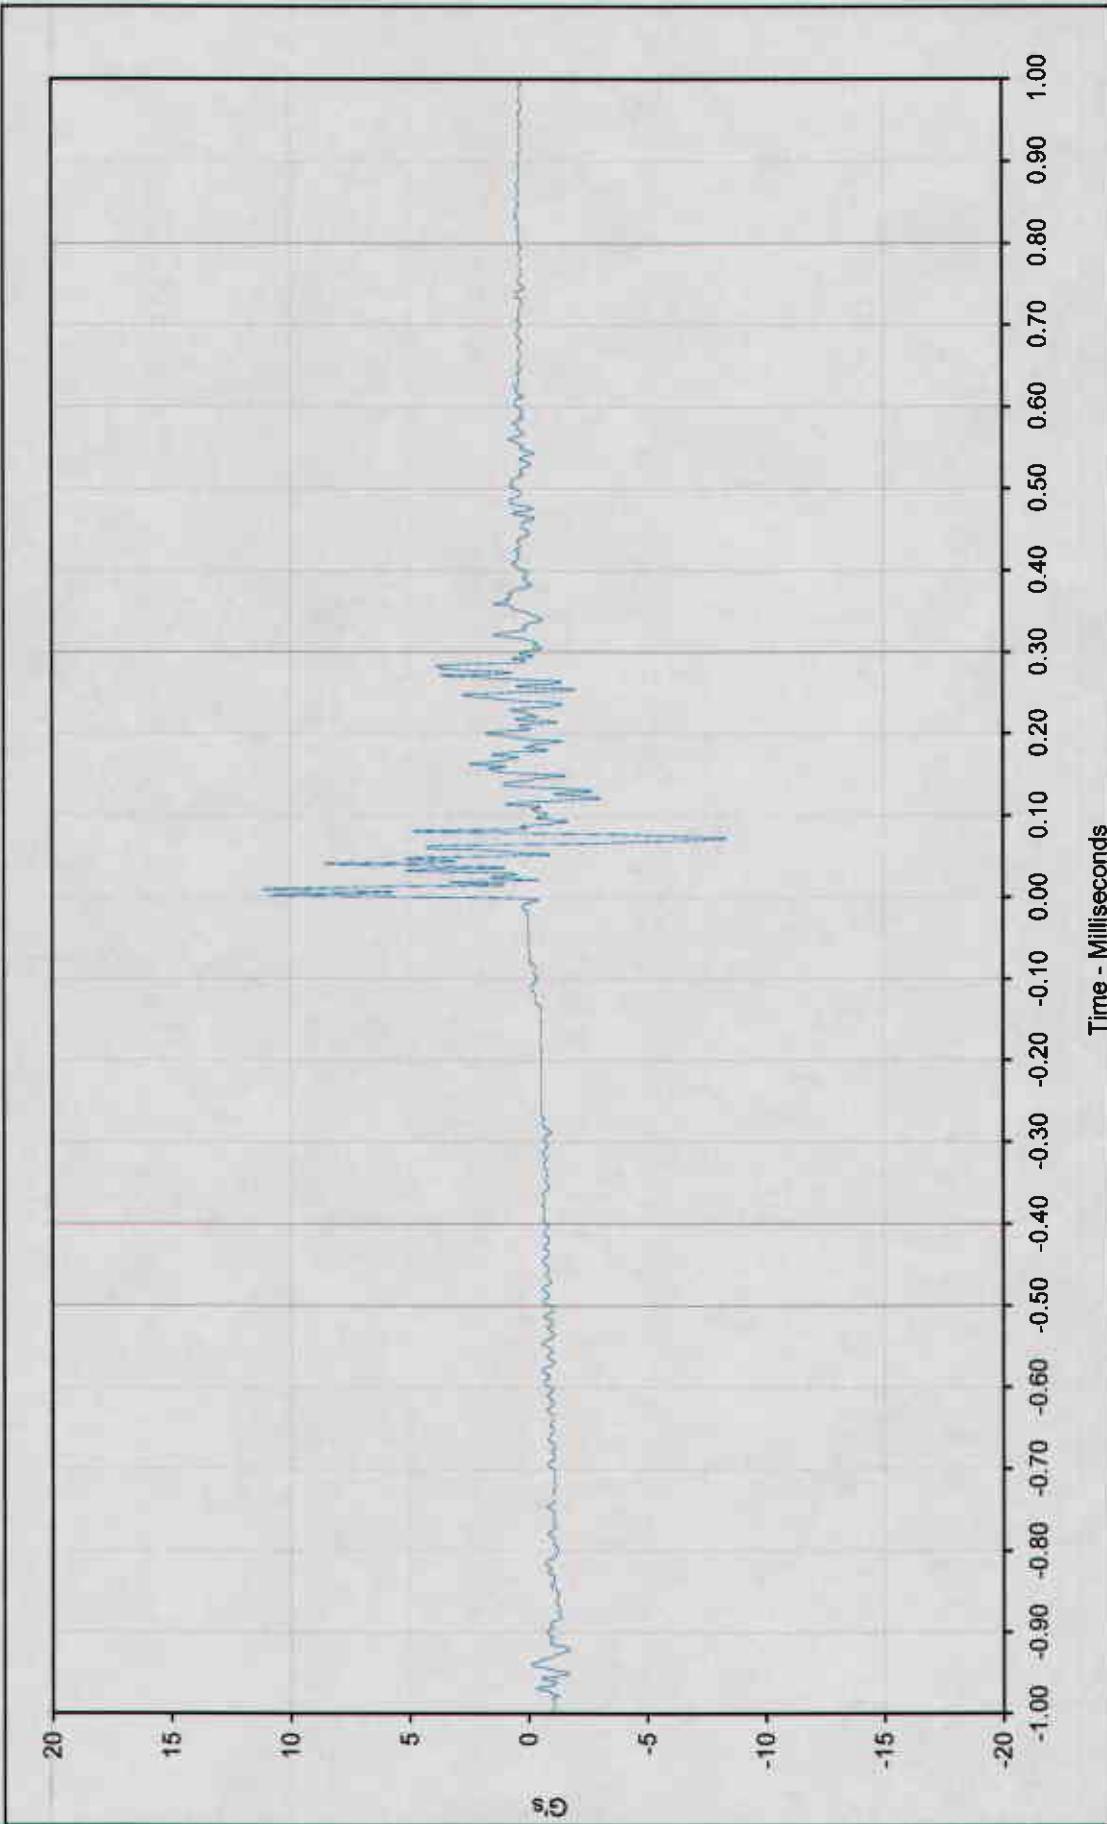
Curve Description	CURNO	Units	Max	Time	Min	Time	SAE Class
Roof Rail Acceleration z	006	G's	11.1	0.009	-8.3	0.072	60

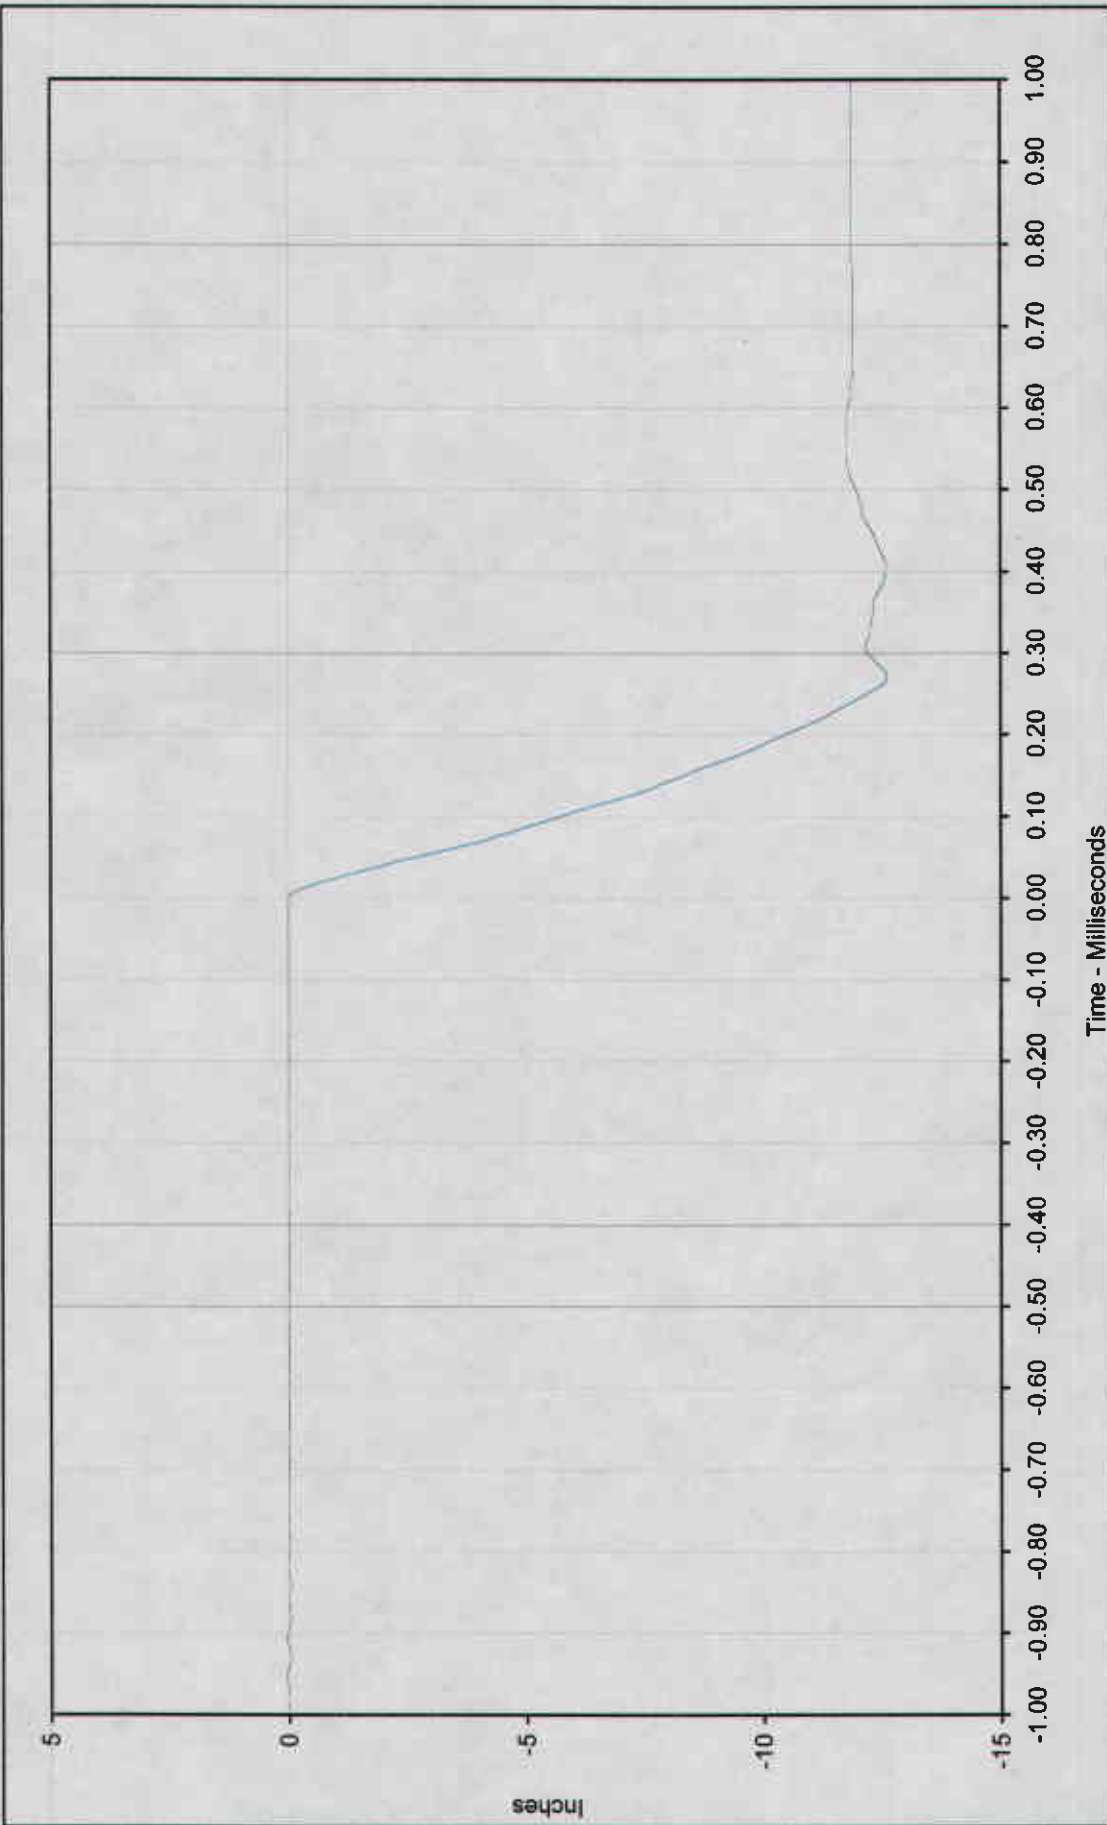
Curve Description	CURNO	Units	Max	Time	Min	Time	SAE Class
Roof Displacement	007	Inches	0.1	-1.000	-12.6	0.271	60

Table 1 below summarizes the test results. The maximum deformation at the passenger's A-pillar during the primary impact was approximately 12.6" dynamically as measured at the displacement transducer. (See Appendix B for complete data).
